A1

Trouble-shooting program

With these instructions it is possible to test Mercedes-Benz passenger cars of type W 124 equipped with electronic automatic air conditioner with blower control which is installed as an optional extra.

Rapid diagnosis chart
Mercedes Benz W 124

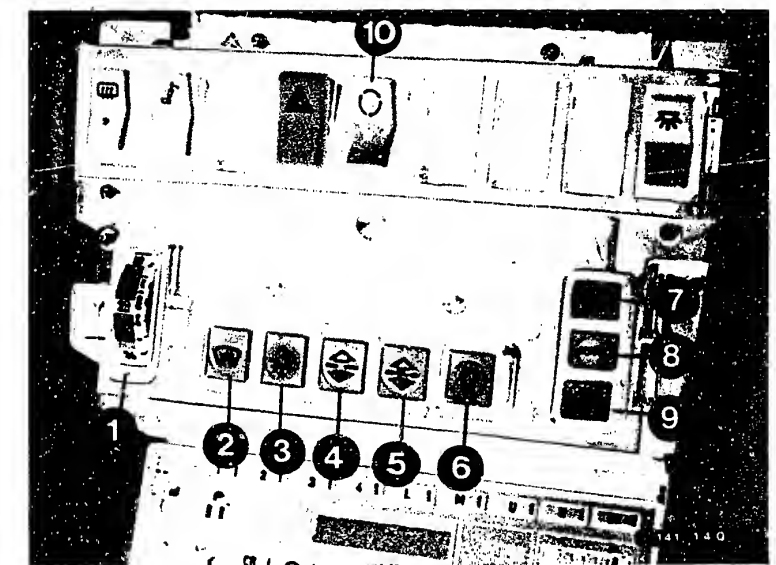
- 1 = Temperature selector thumbwheel
- 2 = Button "DEF"
- 3 = Button "BI-LEV"
- 4 = Button "AC"
- 5 = Button "EC"
- 6 = Button "O"
- 7 = "Max" blower speed button
- 8 = "AUTO" blower speed button
- 9 = "Min" blower speed button
- 10 = Fresh/recirculated air switch

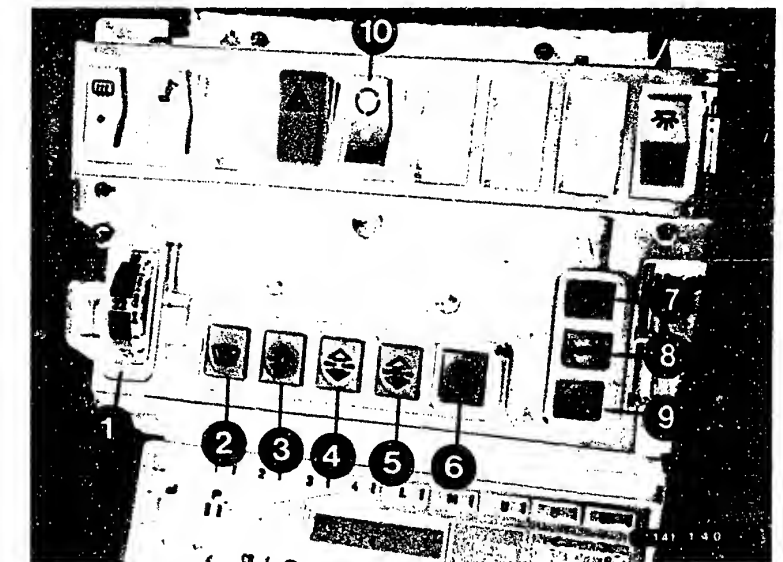
- 1 = Temperature selector thumbwheel
- 2 = Button "DEF"
- 3 = Button "BI-LEV"
- 4 = Button "AC"
- 5 = Button "EC"
- 6 = Button "O"
- 7 = "Max" blower speed button
- 8 = "AUTO" blower speed button
- 9 = "Min" blower speed button
- 10 = Fresh/recirculated air switch

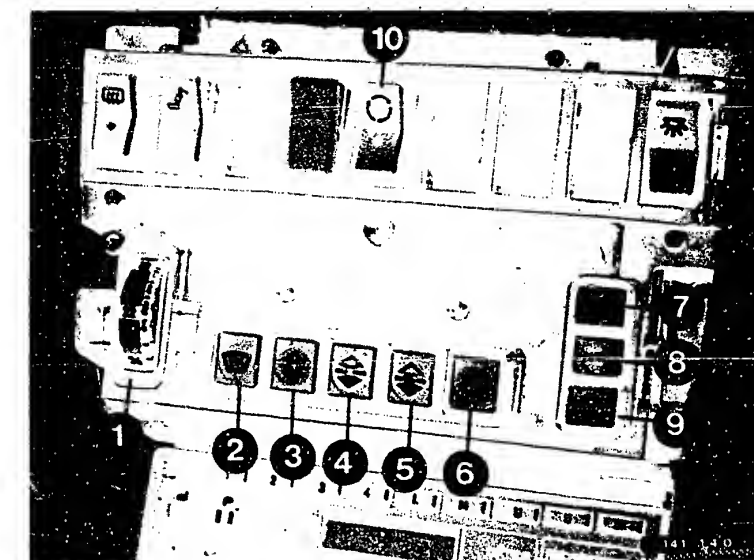
- 1 = Temperature selector thumbwheel
- 2 = Button "DEF"
- 3 = Button "BI-LEV"
- 4 = Button "AC"
- 5 = Button "EC"
- 6 = Button "O"
- 7 = "Max" blower speed button
- 8 = "AUTO" blower speed button
- 9 = "Min" blower speed button
- 10 = Fresh/recirculated air switch

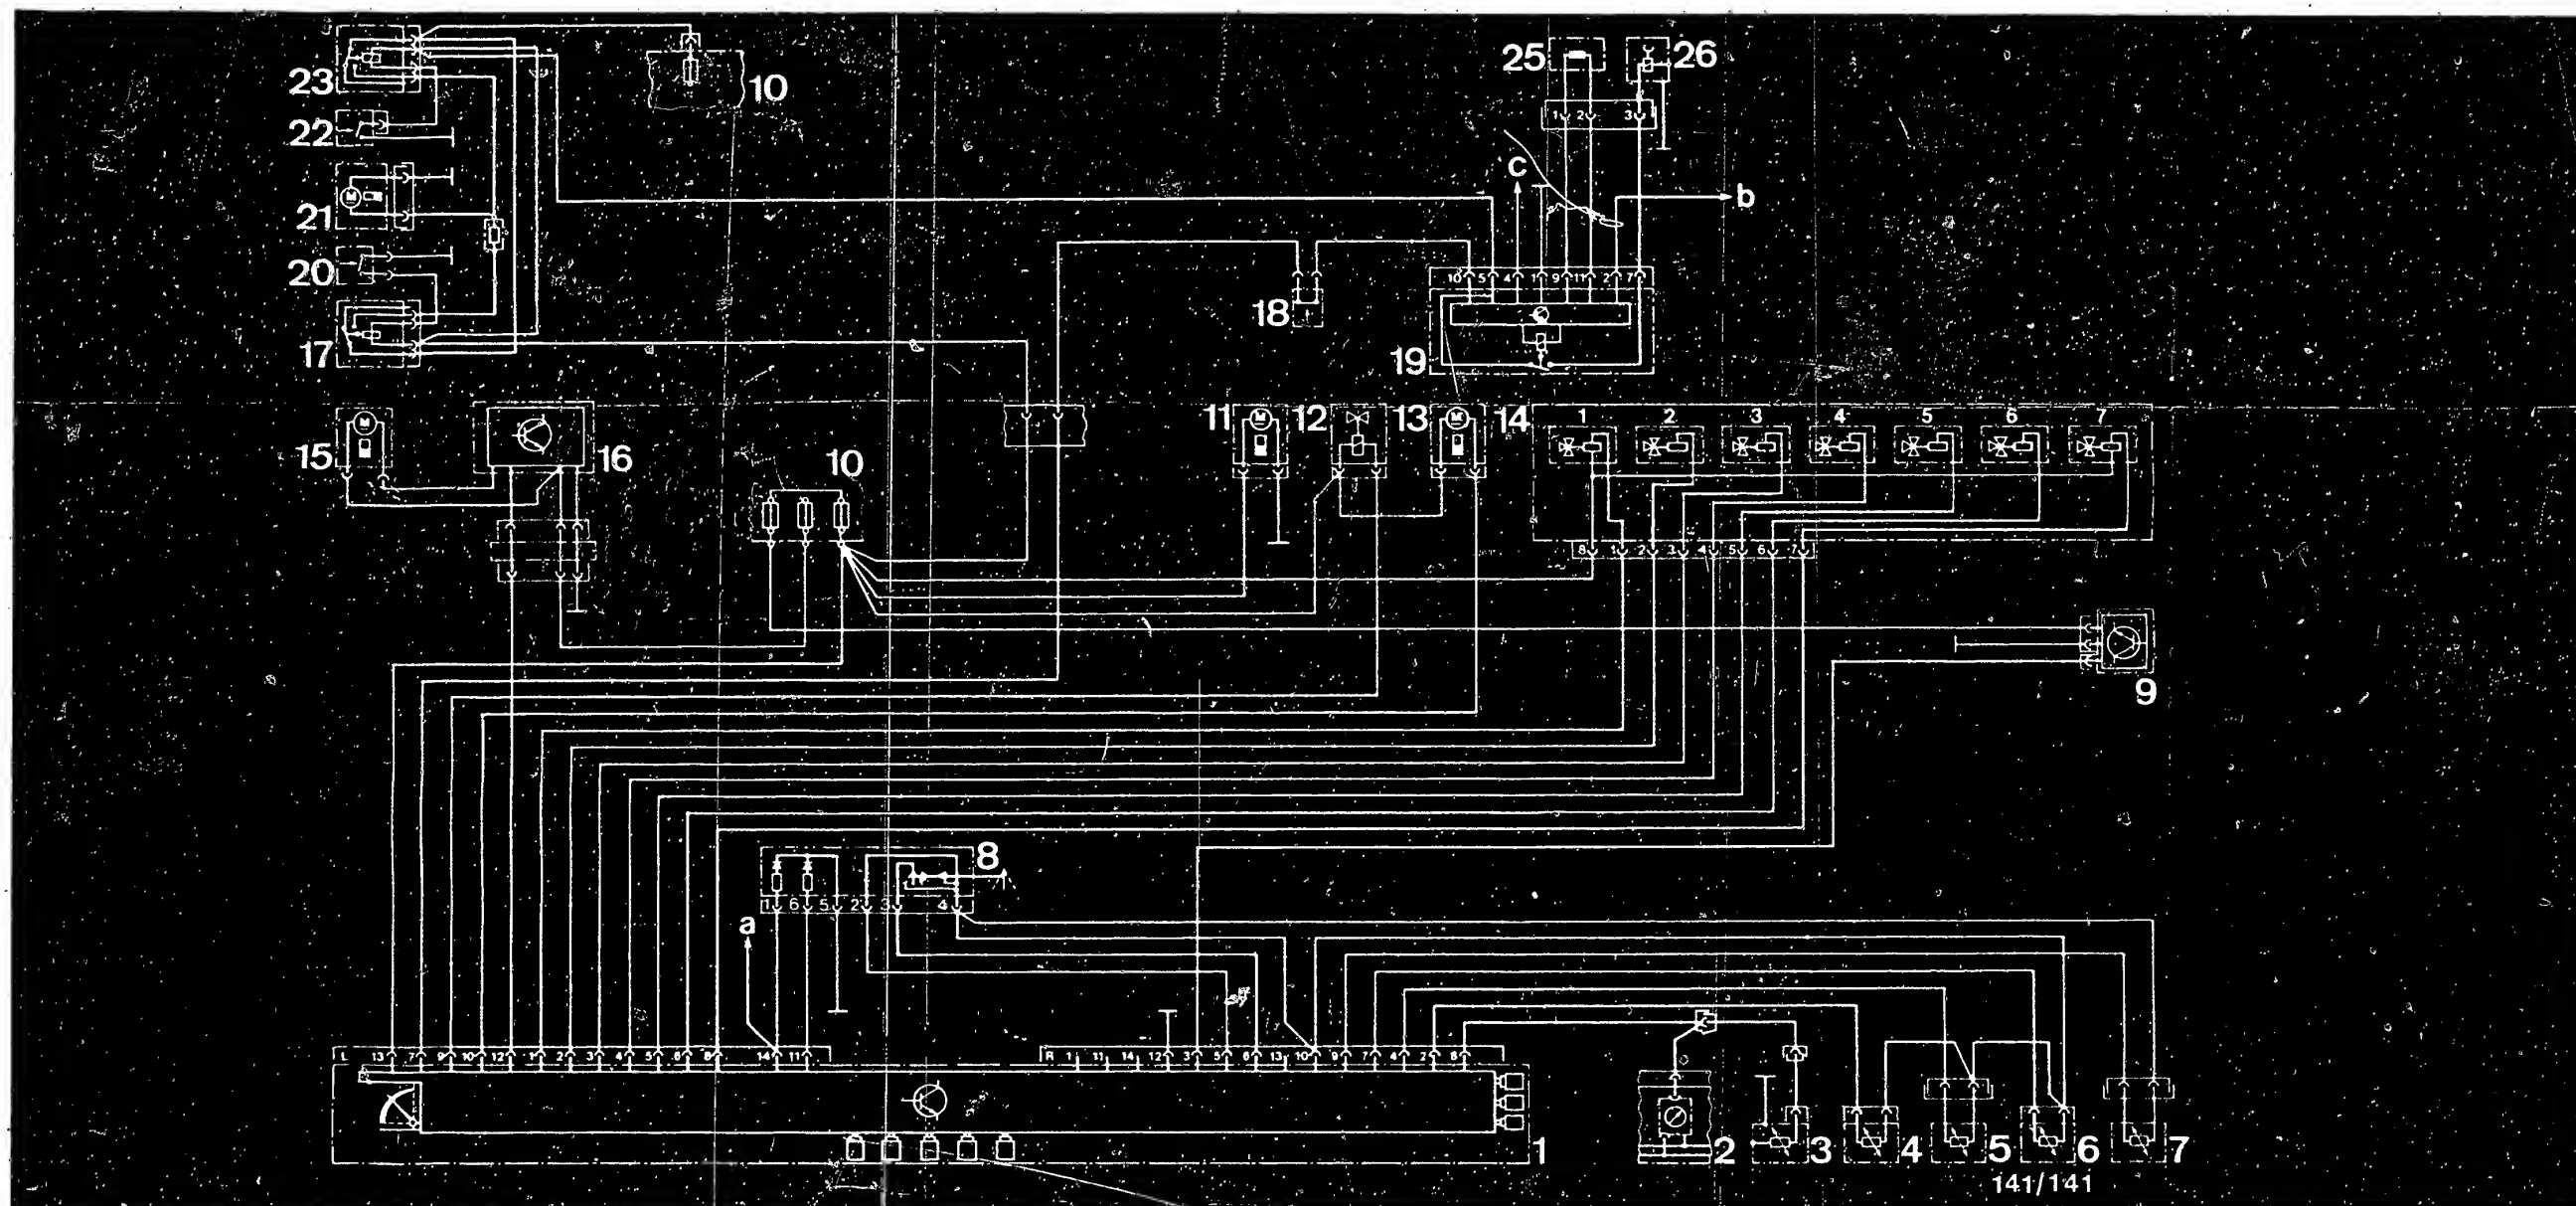
15 = Blower motor
 16 = Blower controller
 17 = Series resistor auxiliary fan relay
 18 = Refrigerant compressor pressure switch
 off 2.0 bar/on 20 bar

19 = Compressor cutoff control unit
 20 = Auxiliary fan pressure switch
 off 15 bar/on 20 bar
 21 = Auxiliary fan

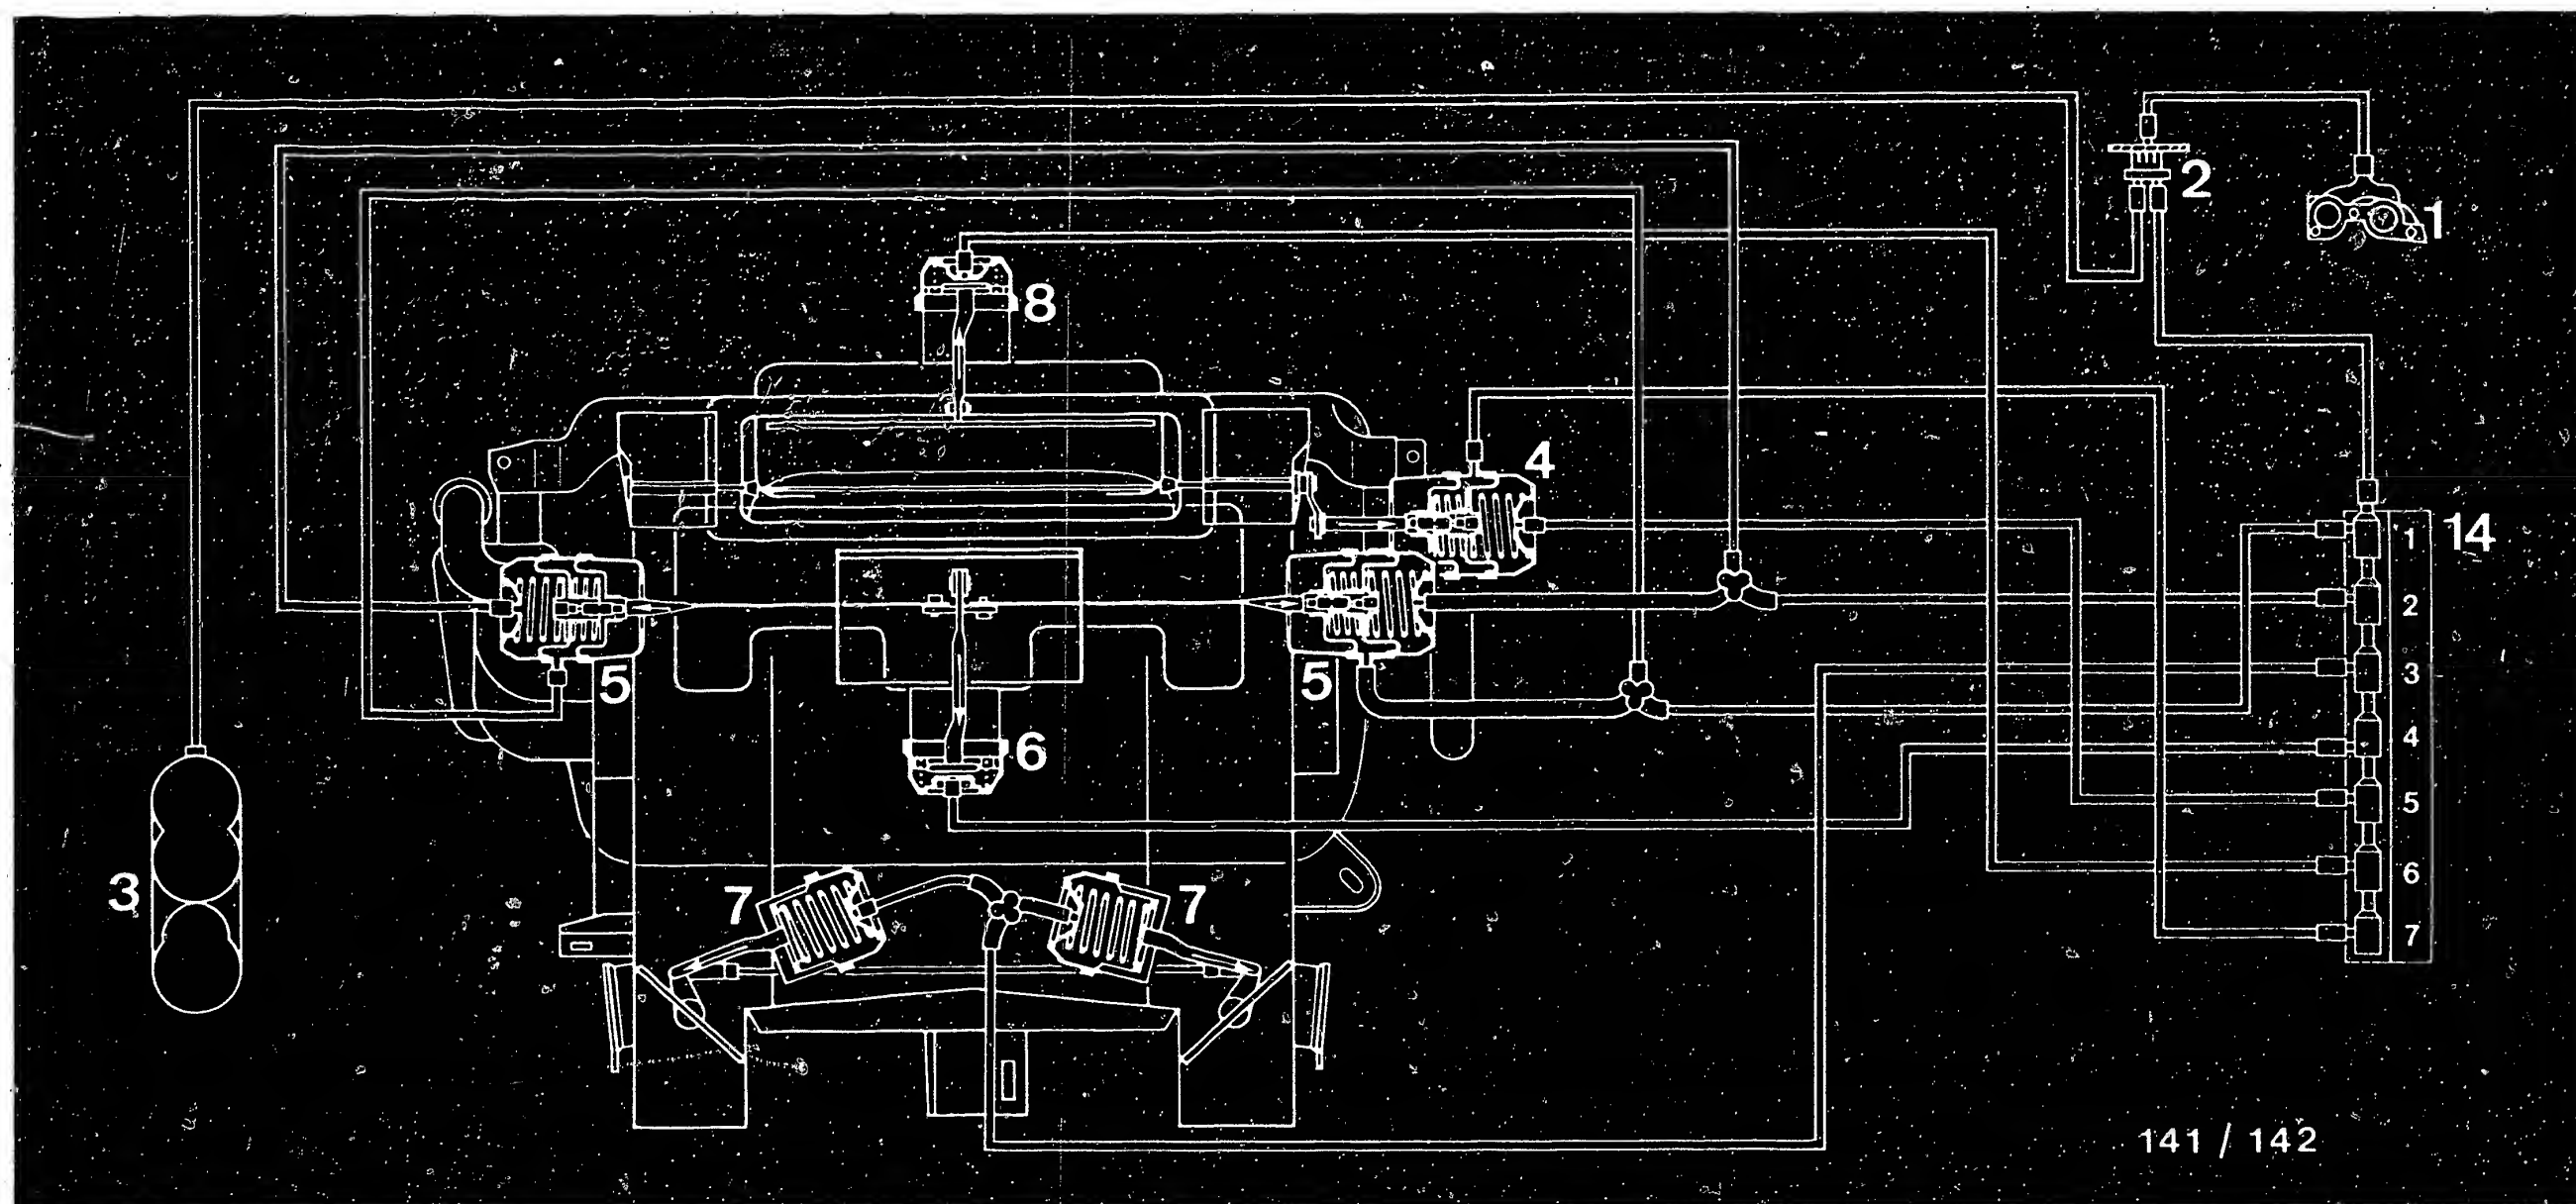
- 1 = Vacuum connection on intake manifold
- 2 = Non-return valve
- 3 = Vacuum supply tank (except on diesel vehicles)
- 4 = Defroster nozzle flap vacuum element
- 5 = Fresh/recirculated air flap vacuum element
- 6 = Center nozzle flap vacuum element

- 7 = Footwell flap vacuum element
- 8 = Skimming flap vacuum element
- 14 = Change-over valve strip
- 14.1 = Fresh/recirculated air flap (small stroke)
- 14.2 = Fresh/recirculated air flap (large stroke)
- 14.3 = Footwell flap change-over valve
- 14.4 = Center nozzle flap change-over valve

- 14.5 = Defroster nozzle flap change-over valve (large stroke)
- 14.6 = Skimming flap change-over valve
- 14.7 = Defroster nozzle flap change-over valve (small stroke)

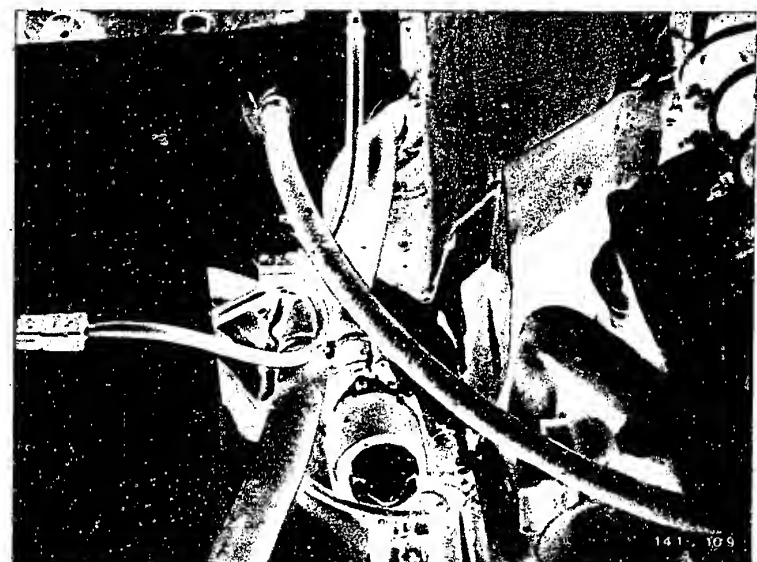
B1

The heating water pump is mounted on the right-hand firewall (see bottom picture).

Installation position of components
Mercedes Benz W 124

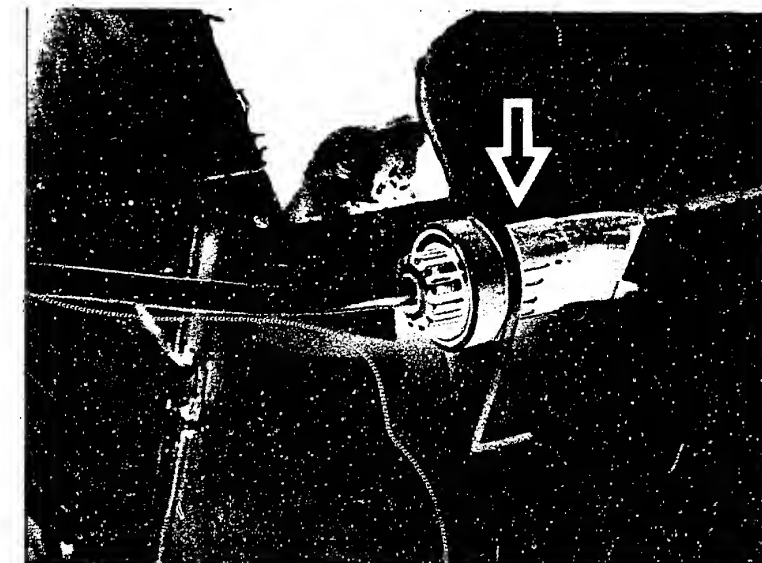
The outside temperature sensor is mounted on the blower box (see top picture).

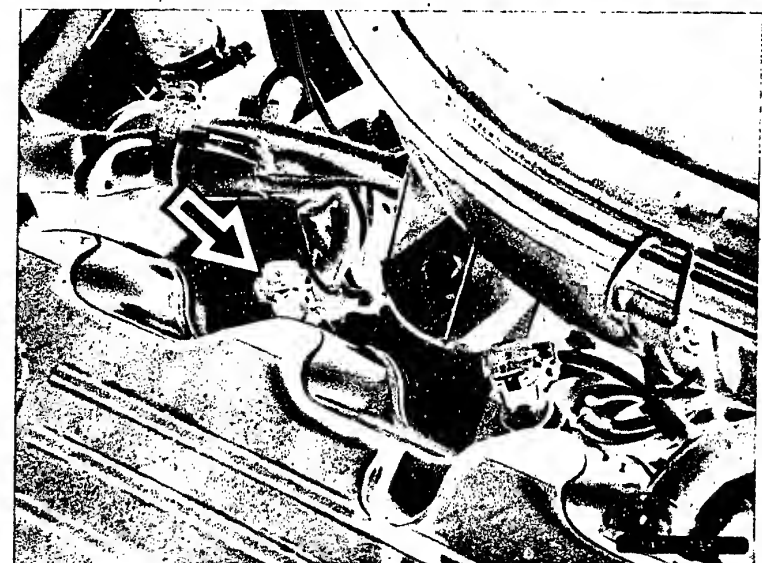
The coolant temperature sensor (see bottom picture, arrow) is installed in the intake manifold.

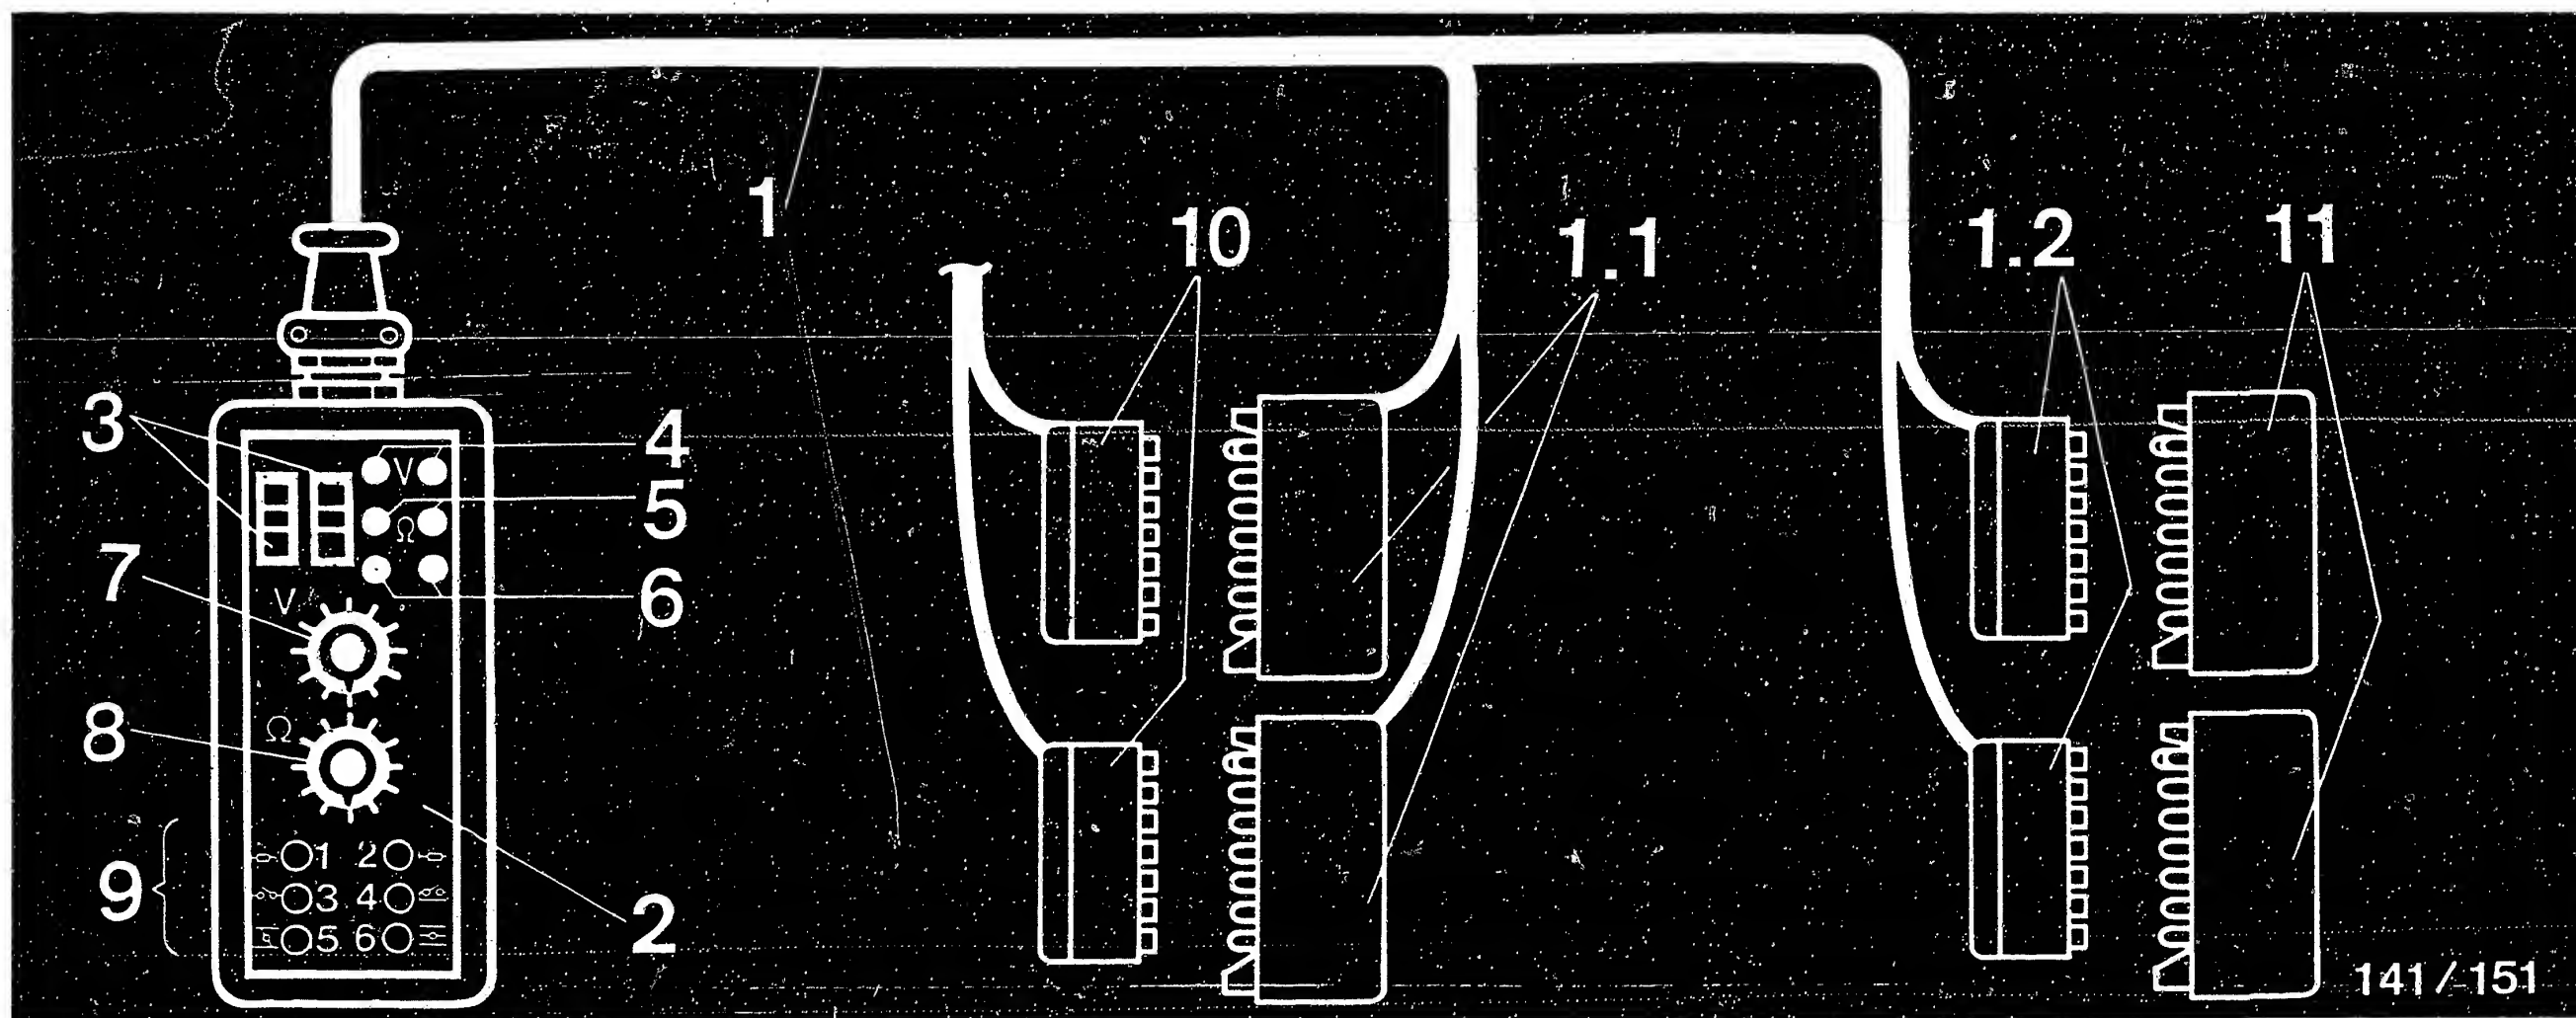
Universal test adapter with adapter lead for automatic air conditioner

- 1 = Adapter lead KDHK 0010
- 1.1 = Connection to wiring harness
- 1.2 = Connection to control unit
- 2 = Universal test adapter (part No.: 0 684 101 801)
- 3 = Test wells (for motortester)
- 4 = Test sockets (for voltage measurements)
- 5 = Test sockets (for resistance measurement)

- 6 = Sockets (must be jumped for testing automatic air conditioner)
- 7 = "V" program switch
- 8 = "Ω" program switch
- 9 = Button panel for simulation of operating conditions
- Button 1 = Evaporator temperature sensor cold (<5°C)

- Button 4 = Coolant temperature sensor hot (>120°C)
- Button 5 = Outside temperature sensor cold
- Button 6 = Outside temperature sensor hot
- 10 = Automatic air conditioner wiring harness
- 11 = Control unit

Test step 1: Switch off ignition; disconnect control unit plug from automatic air conditioner control unit and connect to adapter lead. Jump sockets 1 and 2 on universal test adapter.

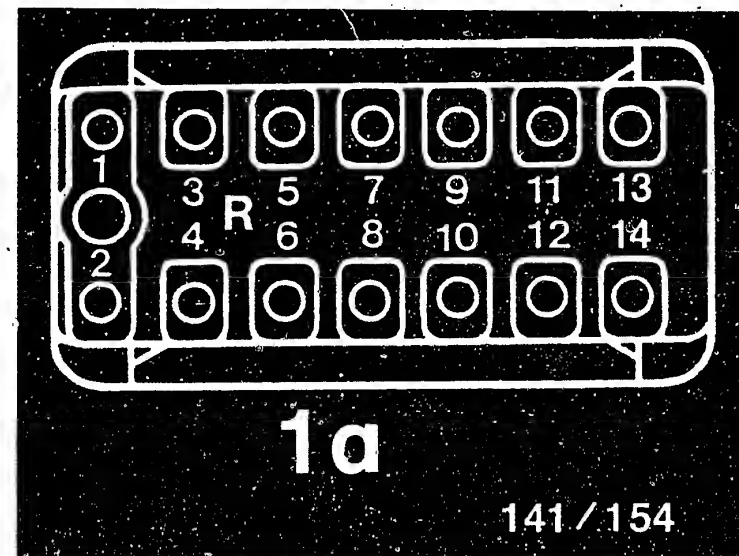
1a = Control unit plug, right

10 = Passenger-compartment temperature sensor

Fault rectification:

Eliminate contact resistances/open circuits on leads or replace temperature sensor.

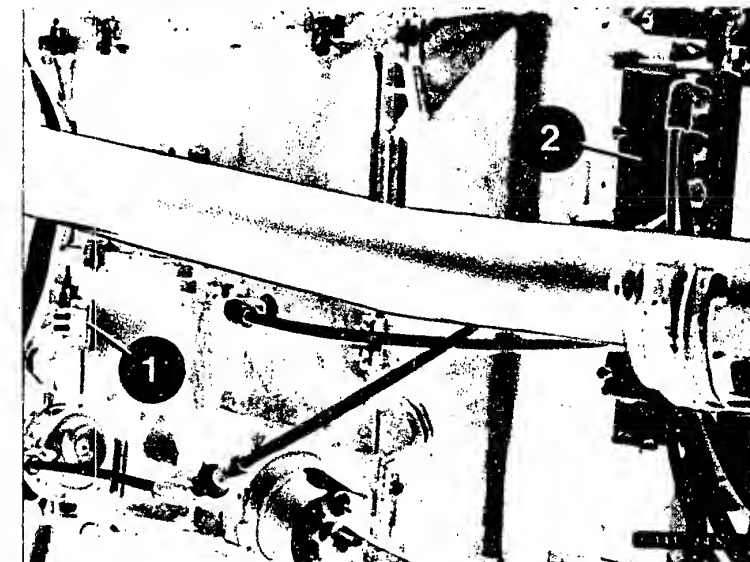
Trouble-shooting:
Check the following leads for continuity with ohmmeter:
(Specification approx. 0 Ω)
- From control unit plug (1a) socket 7 to plug of blow-in temperature sensor
- From control unit plug (1a) socket 10 to plug of blow-in temperature sensor.
On control unit plug (1a) check socket 7 to socket 10:
Reading should be: ∞Ω
(Plug of blow-in temperature sensor disconnected).
Check resistance of blow-in temperature sensor directly between pins of blow-in temperature sensor:
Reading should be:
approx. 15...6.5 kΩ at
approx. 16...35°C at
temperature sensor

1a = Control unit plug, right
1b = Control unit plug, left

Fault rectification:
Eliminate contact resistances/open circuits on leads or replace blow-in temperature sensor (see top picture, 1).

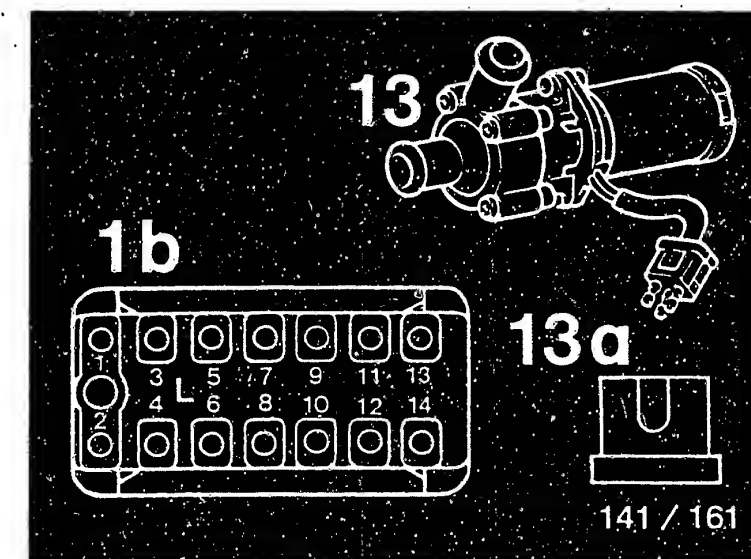
Measuring range: 20 k Ω

Connection: Blue test sockets

Eliminate contact resistances/open circuits on leads.

Replace heating water pump.

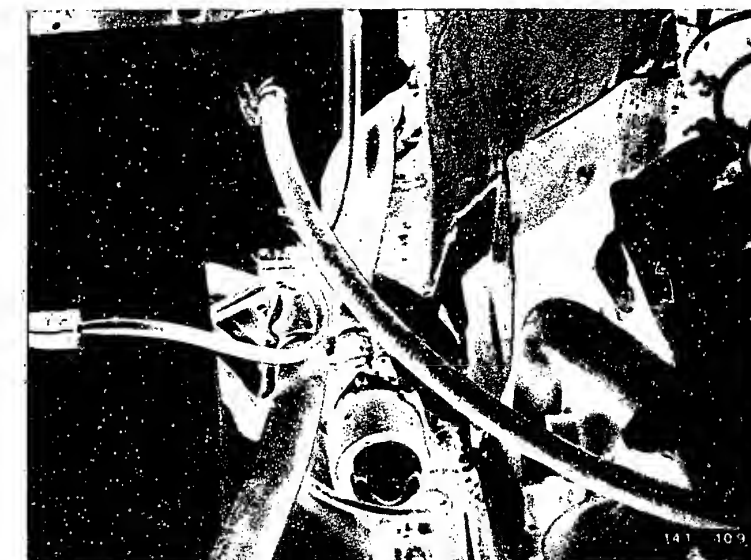
E21

13 = Heating water pump

13a = Plug to heating water pump

| ● | | | | | | Auxiliary heating water pump defective | --- | E 21 |

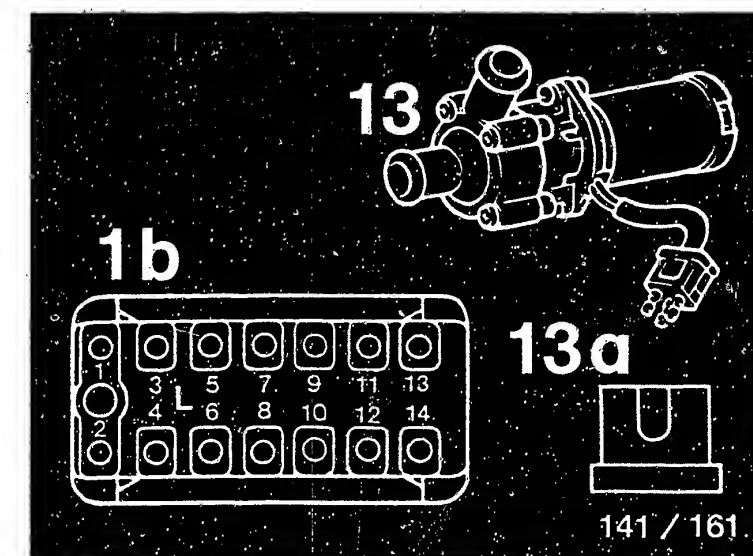
1b = Control unit plug, left
13 = Heating water pump
13a = Plug to heating water pump

Fault rectification:

Eliminate contact resistances/open
circuits on leads.
Replace heating water pump.

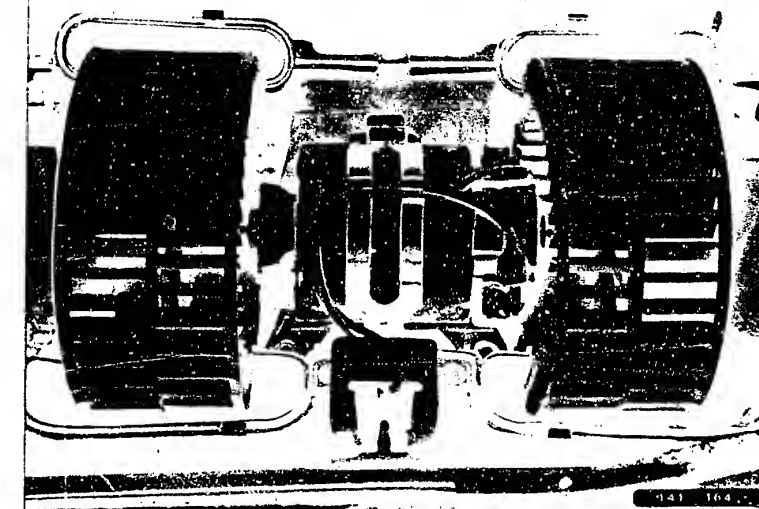
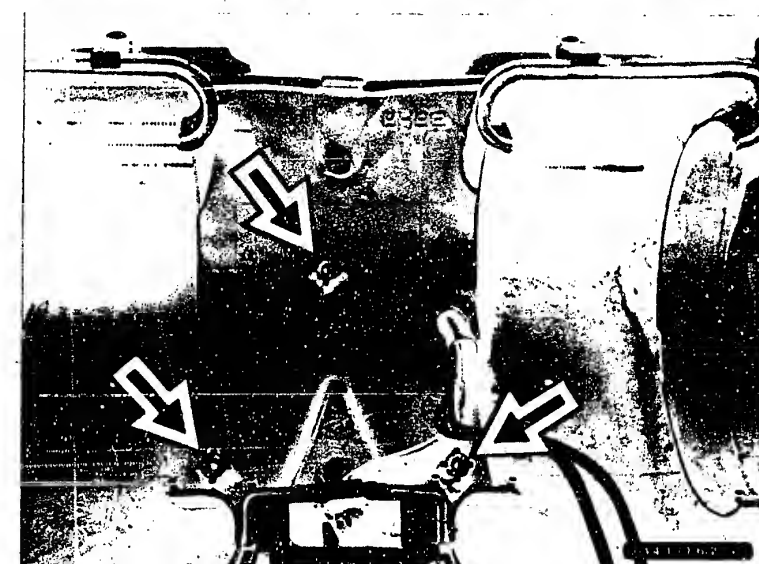
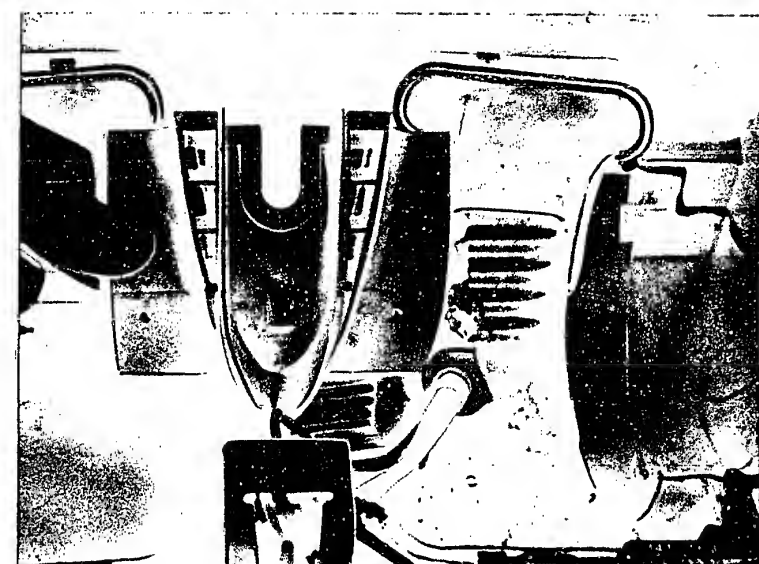
Reading should be: approx. U_B
(ignition on)
Remove blower motor (see top
picture) and test.
If no fault can be found on the
system, blower controller is
defective; replace.
Unscrew fastening screws (see
center picture, arrows), lift off
blower slightly (see bottom picture)
and remove blower controller with
heat sink. Before mounting a new
blower controller on heat sink,
coat contact surface between heat
sink and blower controller with
thermal conduction paste
5 942 860 003.
Re-install new blower controller
with heat sink.

Note: Thermal conduction paste is
poisonous. Clean hands after
applying.

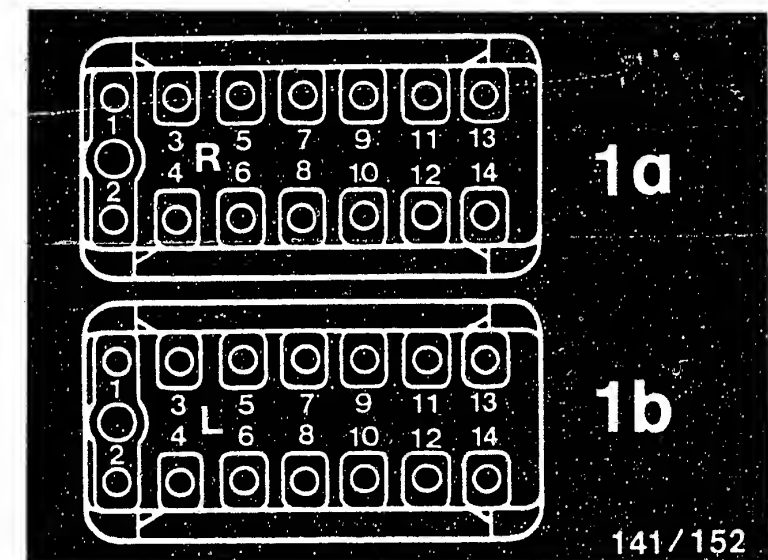
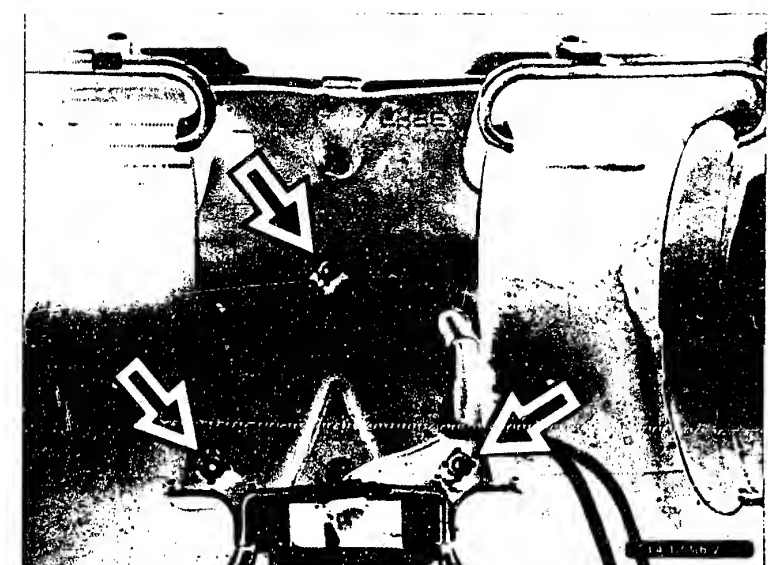
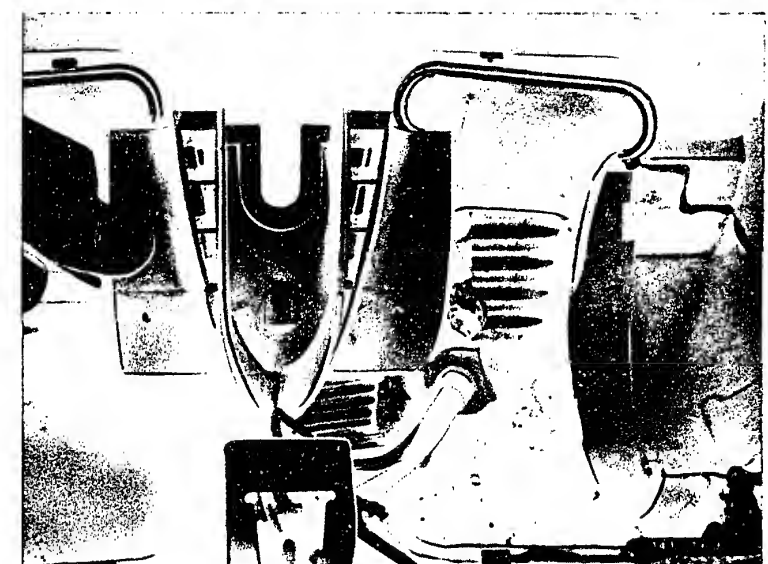
2. Test specification within tolerance and blower speed does not increase:
Using voltmeter, check from plug of blower controller socket 2 to ground and socket 1 to + (term. 15):
Reading should be: approx. U_B (ignition on)
Remove blower motor (see top picture) and test.

If no fault can be found on the system, blower controller is defective; replace. Unscrew fastening screws (see center picture, arrows), lift off blower slightly (see bottom picture) and remove blower controller with heat sink. Before mounting a new blower controller on heat sink, coat contact surface between heat sink and blower controller with thermal conduction paste 5 942 860 003. Re-install new blower controller with heat sink.

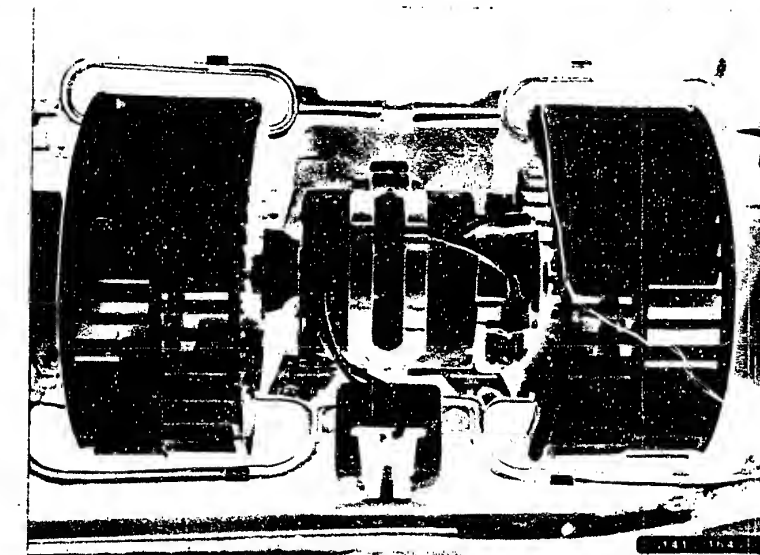
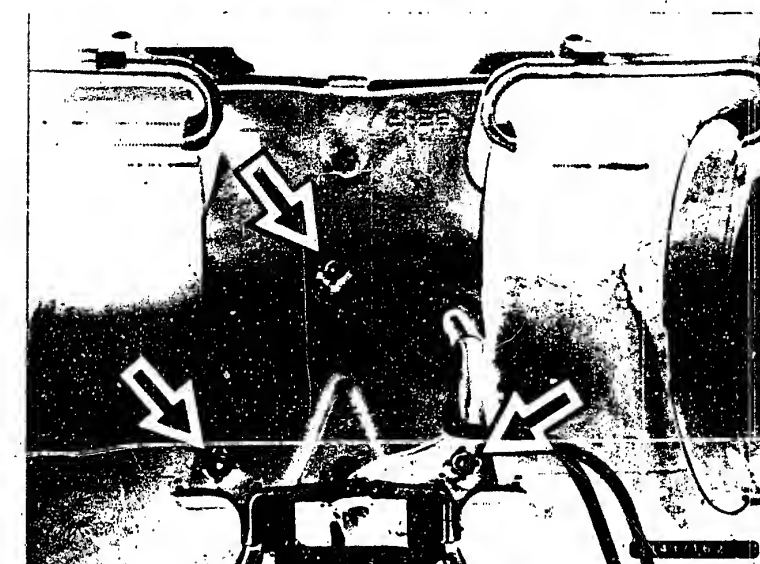
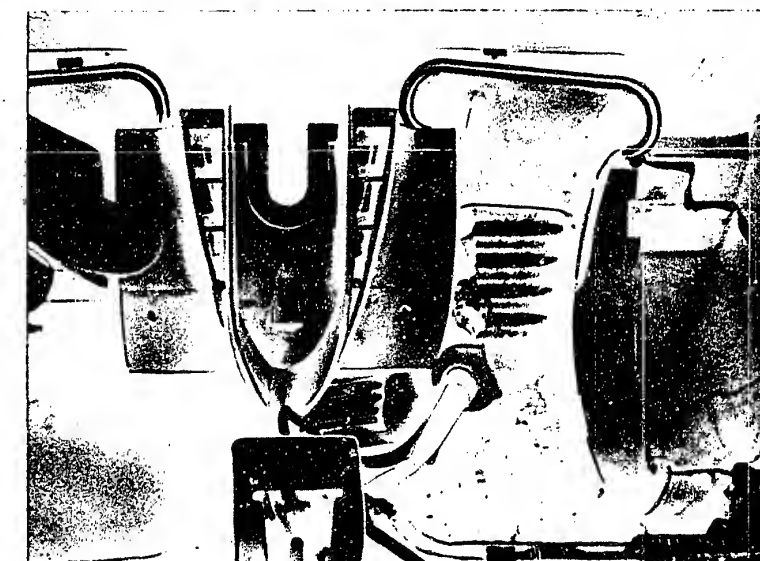
Reading should be: approx. U_B
(ignition on)
Remove blower motor (see top
picture) and test.
If no fault can be found on the
system, blower controller is
defective; replace.
Unscrew fastening screws (see
center picture, arrows), lift off
blower slightly (see bottom picture)
and remove blower controller with
heat sink. Before mounting a new
blower controller on heat sink,
coat contact surface between heat
sink and blower controller with
thermal conduction paste
5 942 860 003.
Re-install new blower controller
with heat sink.

Note: Thermal conduction paste is
poisonous. Clean hands after
applying.

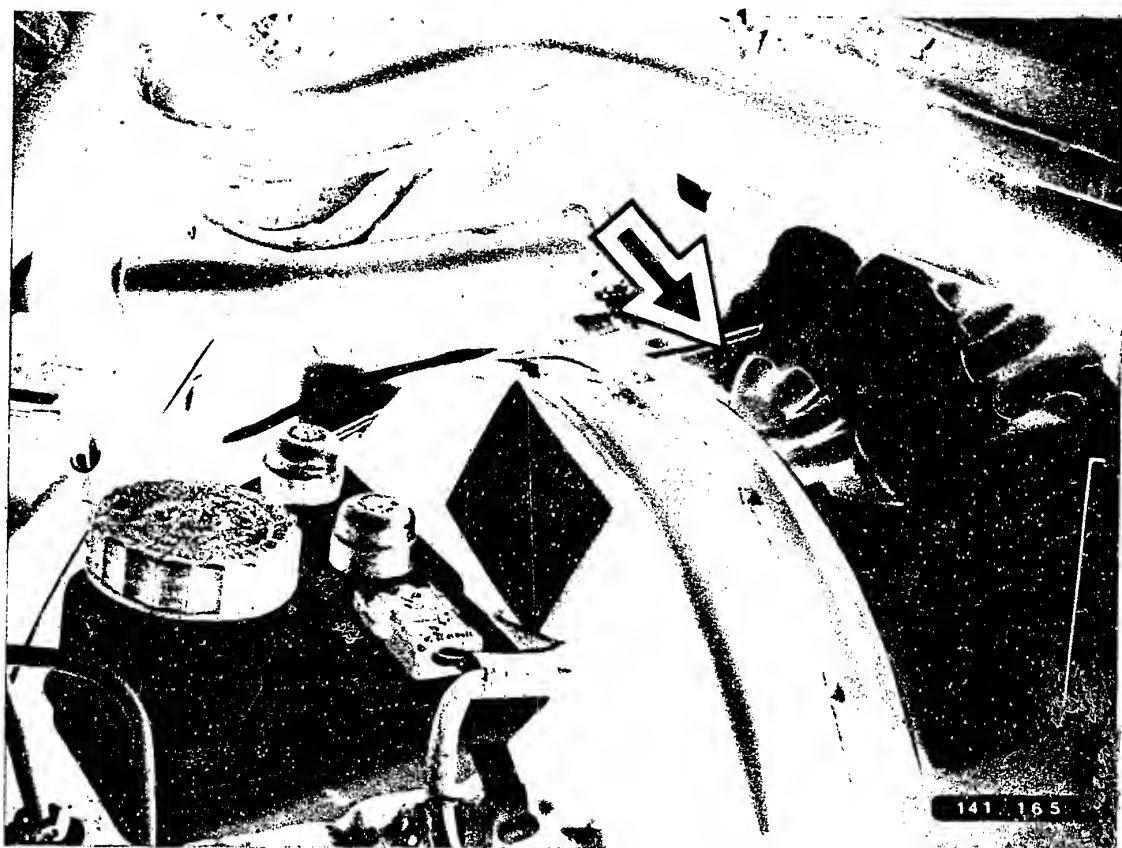
9. Checking the vacuum system for leaks

9.1 Check vacuum tank with line:

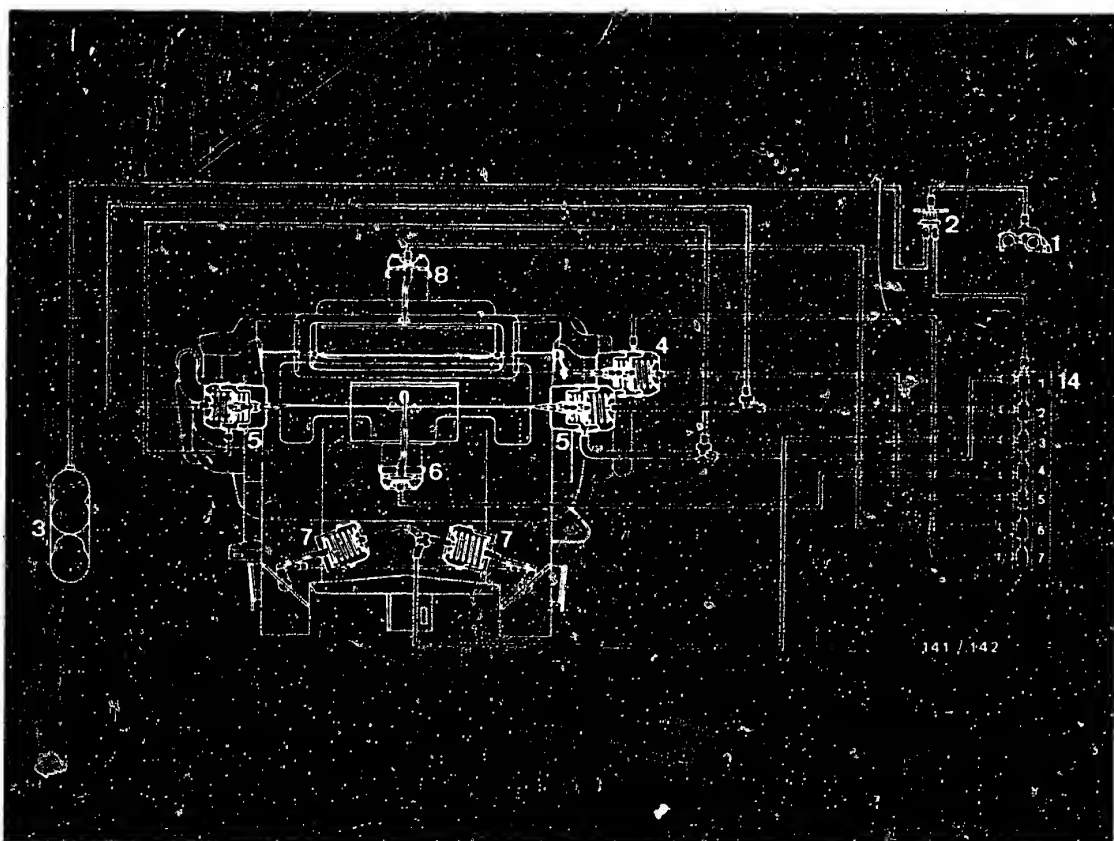
9.2.2 Check vacuum element (5) for fresh/recirculated air flap with vacuum lines:

Press button "0" on control panel and turn temperature selector thumbwheel to latched "max" position. Evacuate (approx. 400 mbar) with vacuum pump. If an appreciable vacuum drop is detectable, check vacuum elements (5) individually and replace if necessary, or check vacuum lines medium green/light blue and dark red and replace if necessary.

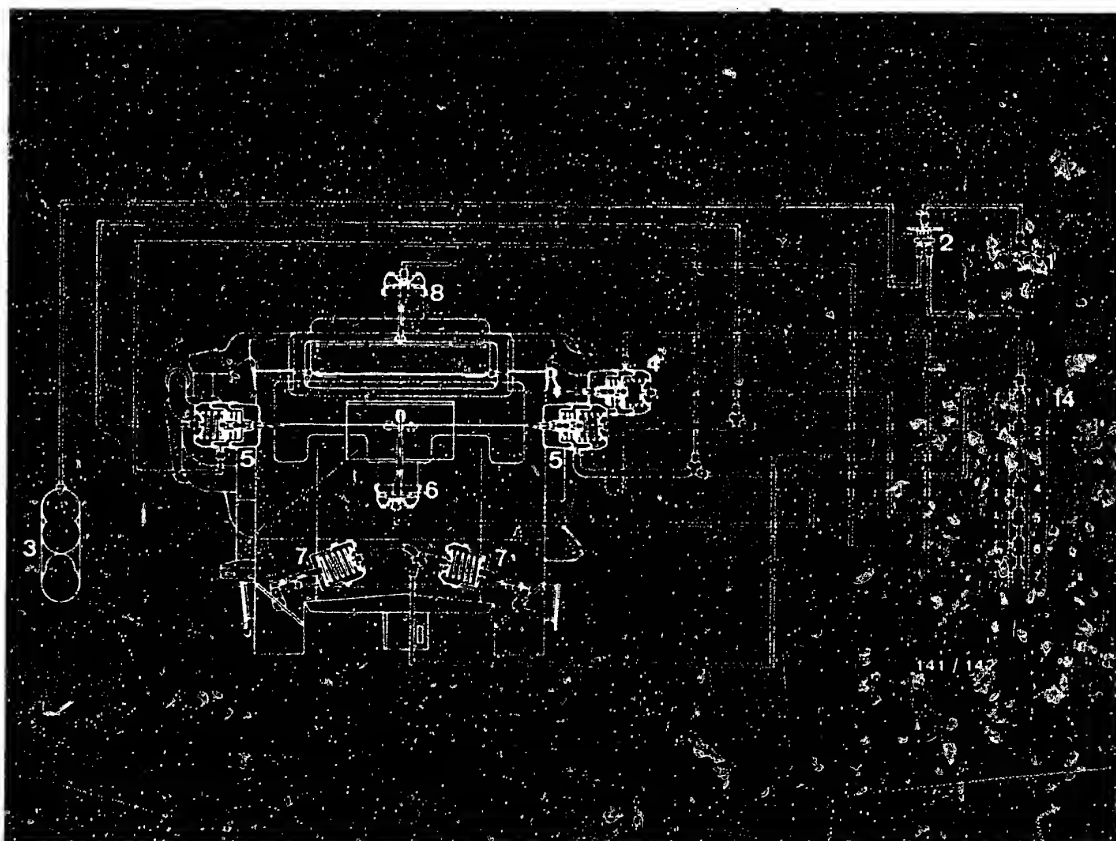
9.2.4 Check vacuum element (6) for center nozzle flap, vacuum element (8) for skimming flap and vacuum element (4) for defroster nozzle flaps with vacuum lines:

Press button "EC" on control panel and turn temperature selector thumbwheel to "min" latched position. Press blower button "min" on control panel.
Evacuate (approx. 400 mbar) with vacuum pump.

If appreciable vacuum drop is detectable, check vacuum elements (4), (6), (8) individually and replace if necessary, or check vacuum lines red/black and medium green and replace if necessary.
